# **REP-REP-RAE8211N55-1165020 Removing and installing / replacing exhaust turbocharger (N55) &comma; VIN: VM11125**

**Removing and installing / replacing exhaust turbocharger (N55)**

The module consists of exhaust turbo charger and exhaust manifold.

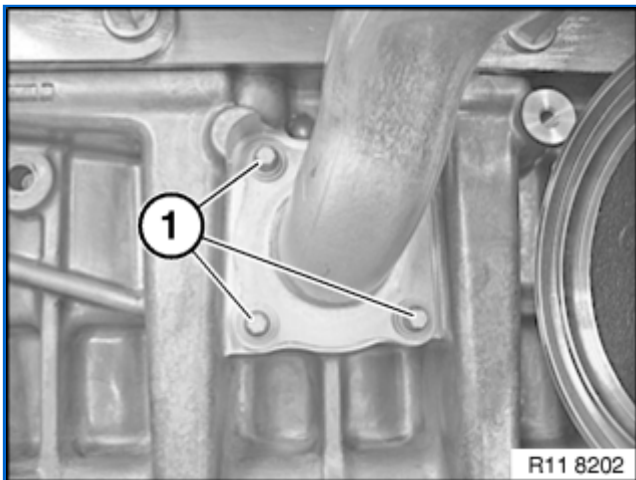
Release screws (1).

Tightening torque [11 53 4AZ](#).

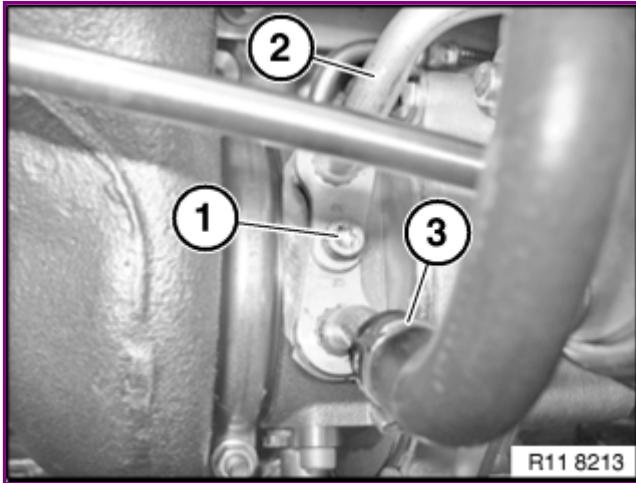
Release screw (1).

Tightening torque [11 53 10AZ](#).

If necessary, use appropriate tool to loosen coolant return line (3) and coolant flow line (2) at connection point.

Replace sealing rings.

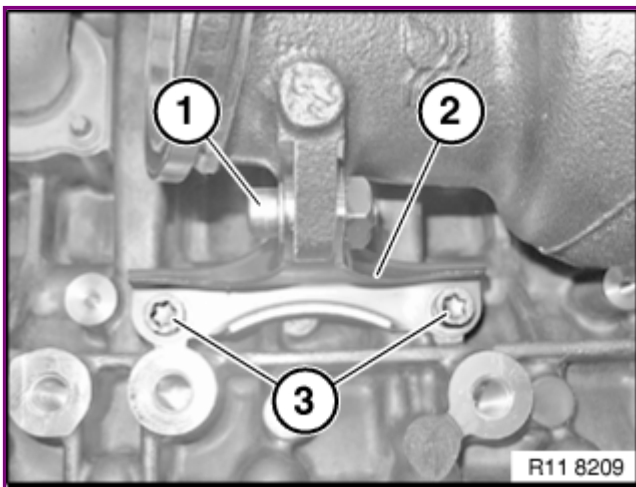
Release screw (1).

Loosen screws (3) but do not remove.

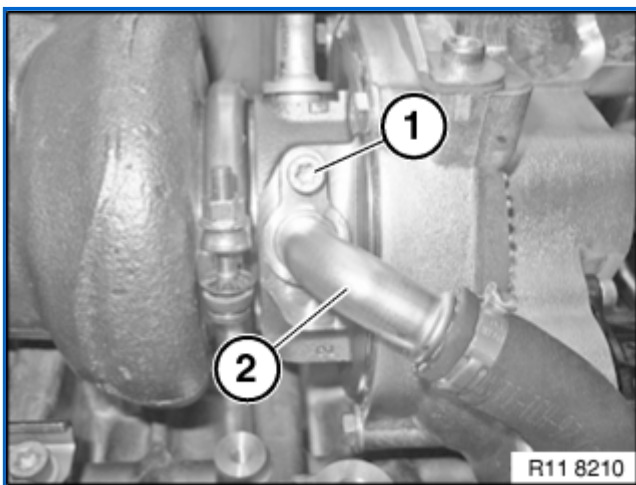
Release screw (1).

Tightening torque [11 42 6AZ](#).

If necessary, use appropriate tool to loosen oil return lines (2).

Replace sealing ring.

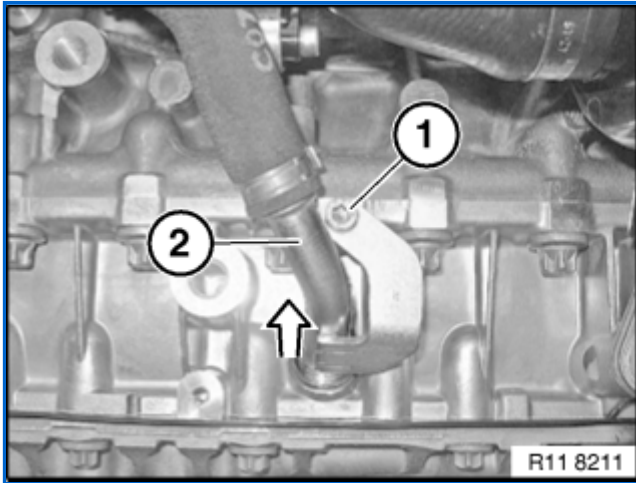
Release screw (1).

Tightening torque [11 42 7AZ](#).

If necessary, use appropriate tool to loosen oil return lines (2).

Possibility of oil escaping when oil return line is disconnected.

Replace sealing ring.

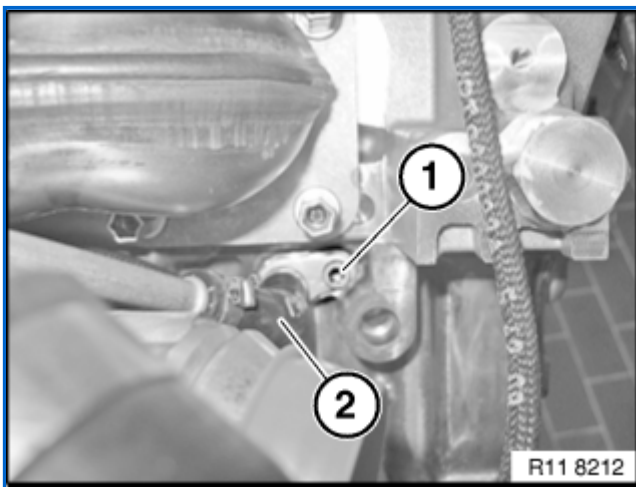
Release screw (1).

Tightening torque: [11 42 4AZ](#).

If necessary, use appropriate tool to loosen coolant return lines (2) at connection point.

Replace sealing ring.

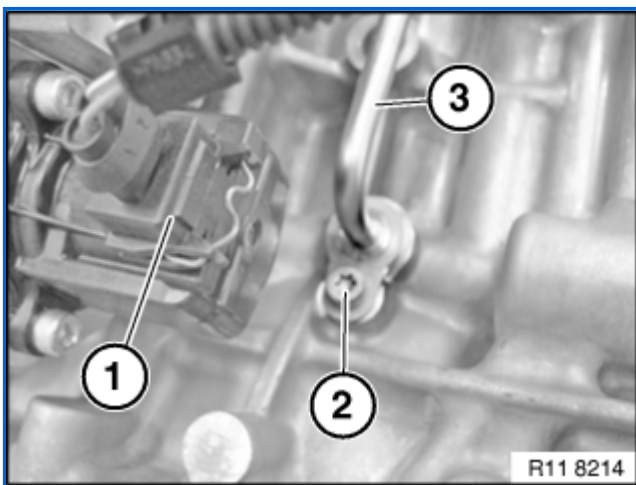
Loosen plug connection (1) at blow-off valve.

Release screw (2).

Tightening torque [11 65 4AZ](#).

If necessary, use appropriate tool to loosen oil feeder lines at point of connection (3).

Replace sealing ring.

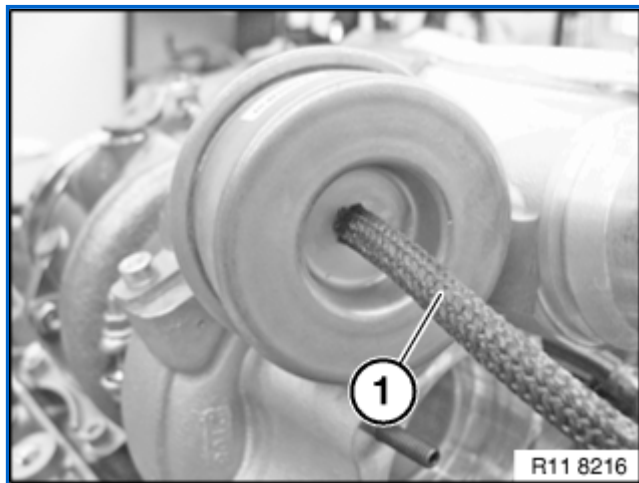
Disconnect vacuum hose (1) from vacuum line.

Disconnect vacuum hose (1) from cylinder head cover.

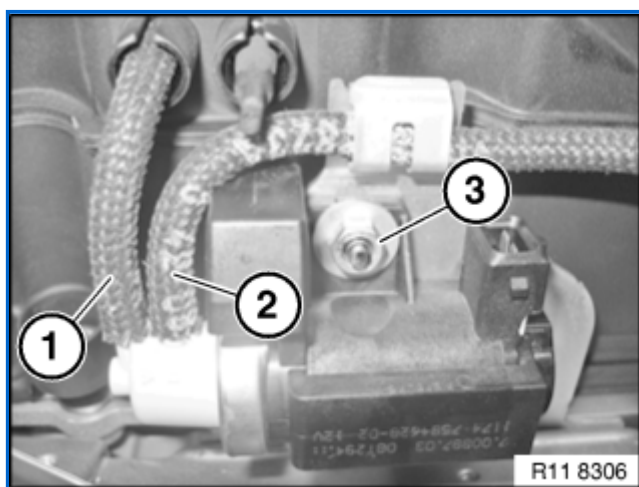
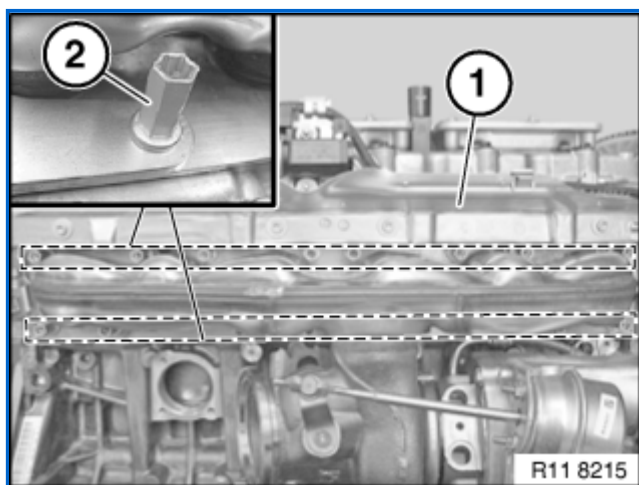
Remove heat shield (1).

Tightening torque: [11 65 2AZ](#)

Loosen all flange nuts (2) along the line.

Remove module by manoeuvring downwards on gearbox side.

Overall weight of module is **approximately 15 kg**.

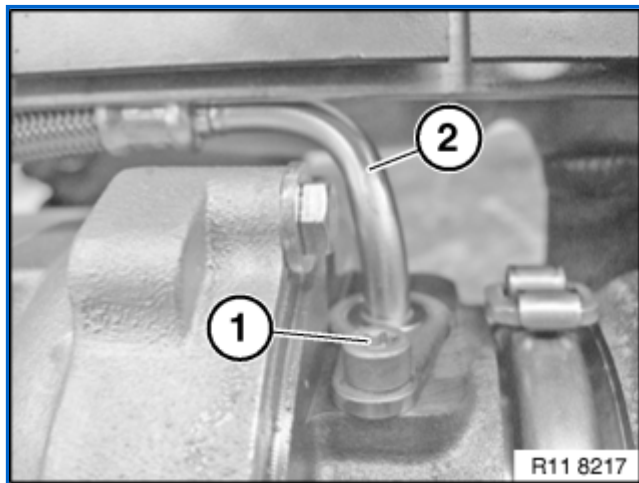
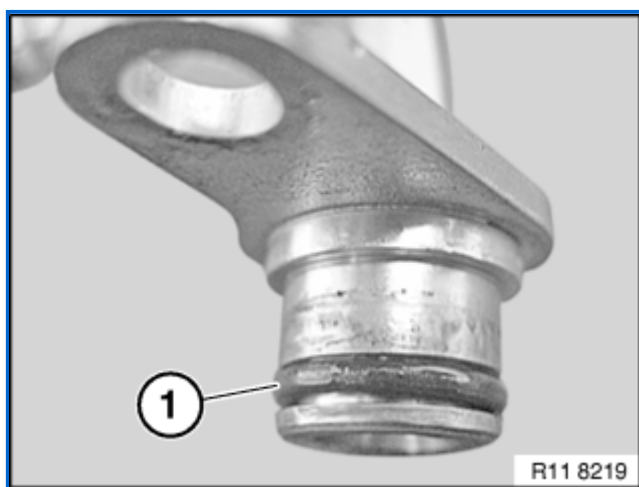
Oil supply line (2) can only be replaced after removal of the turbocharger.

Release screw (1).

If necessary, use appropriate tool to loosen oil feeder lines at point of connection (2).

*Installation note:*  
Replace all sealing rings (1).

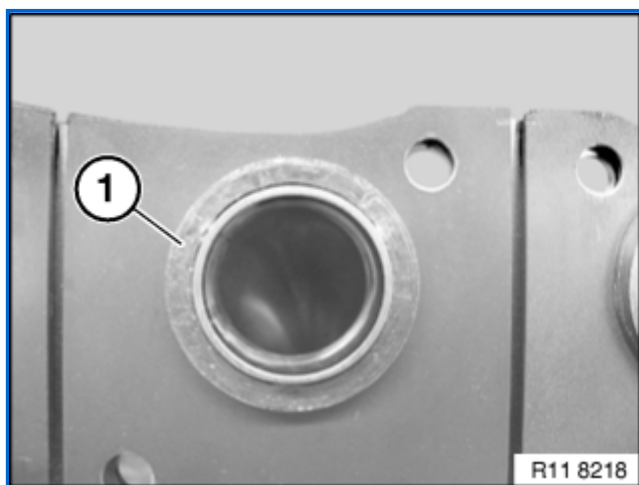
*Installation note:*  
Replace all graphite seals (1).  
Position turbocharger on cylinder head and hold in place with two bolts.

Insert bolt (1) but do not tighten at this point.

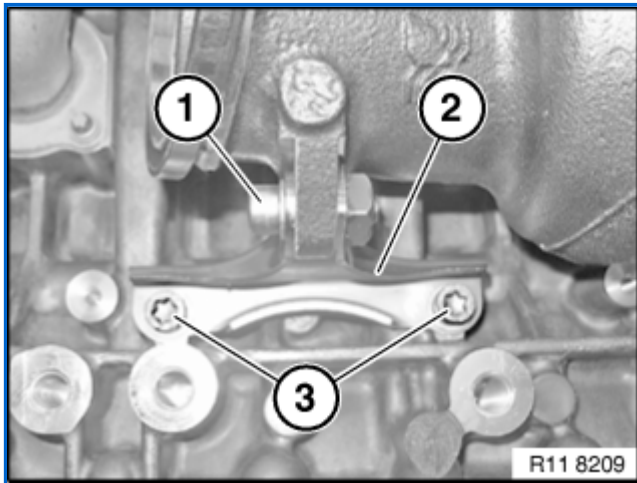
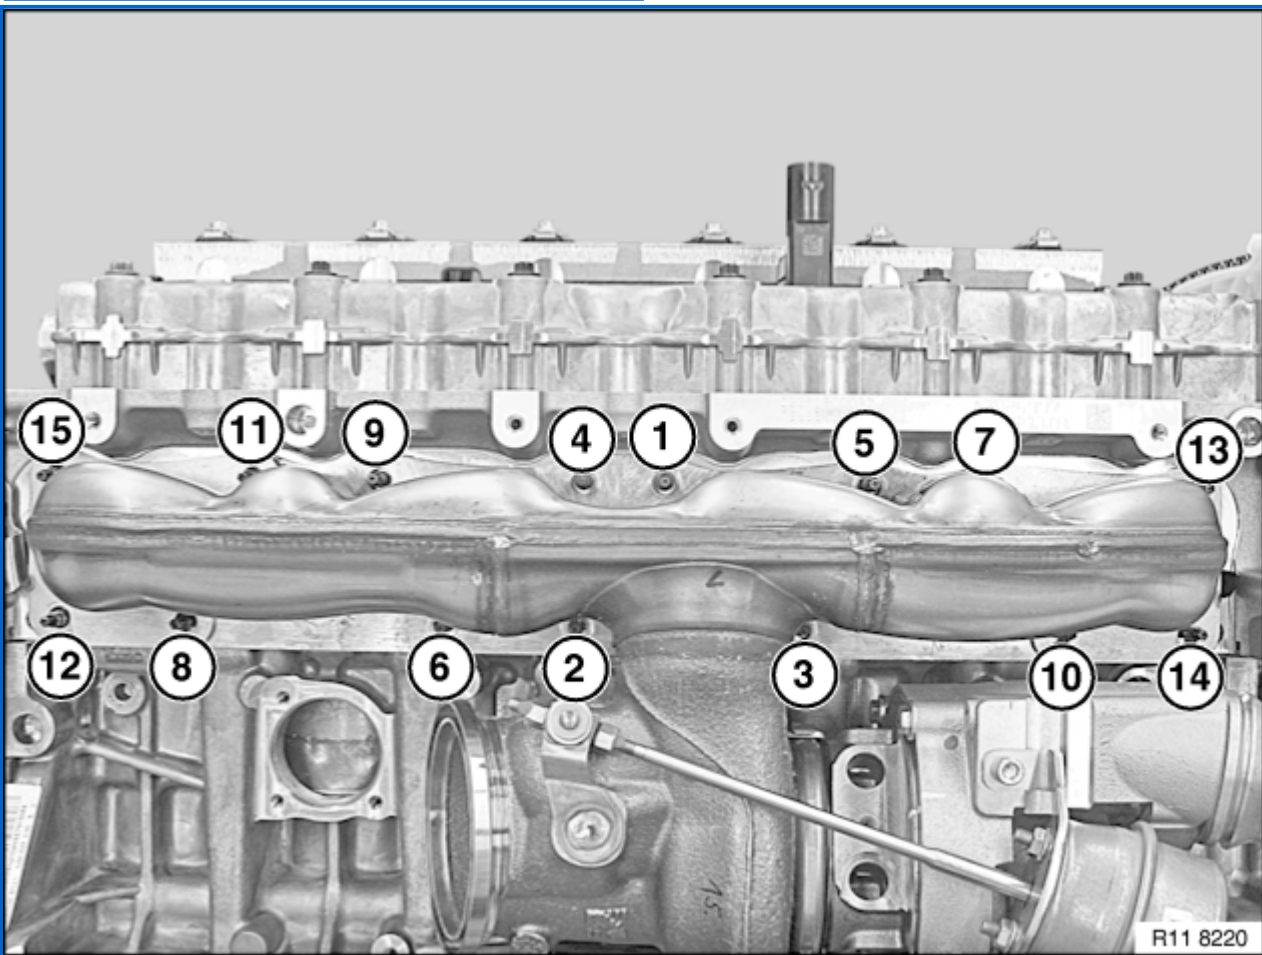
The module consists of exhaust gas turbo loader and exhaust gas manifold and must be installed stress-free.

Torque and torque sequence must be observed without fail.

Tightening torque: [11 65 1AZ](#).

1. Join all flange nuts in sequence 1 to 15 to **8 Nm**.
2. Tighten all flange nuts to a torque of **13 Nm** in sequence (1 to 15).

Flange nuts 1 to 5 are accessible from above.

Flange nuts 6 to 15 are accessible from below.

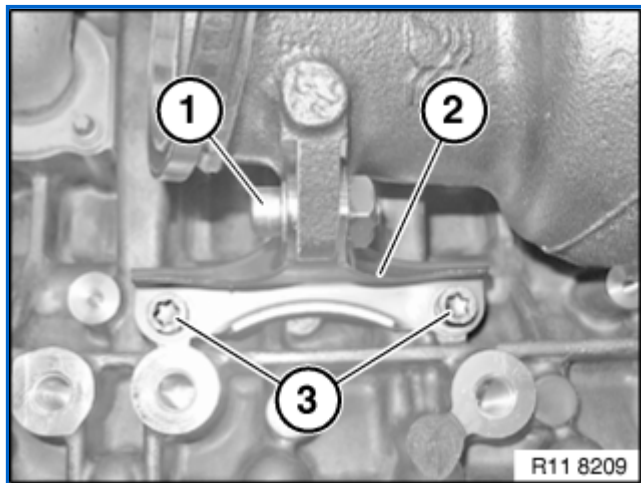
Secure screws (3).

Tightening torque: [11 65 9AZ.](#)

Tighten bolt (1).

Tightening torque [11 65 8AZ.](#)

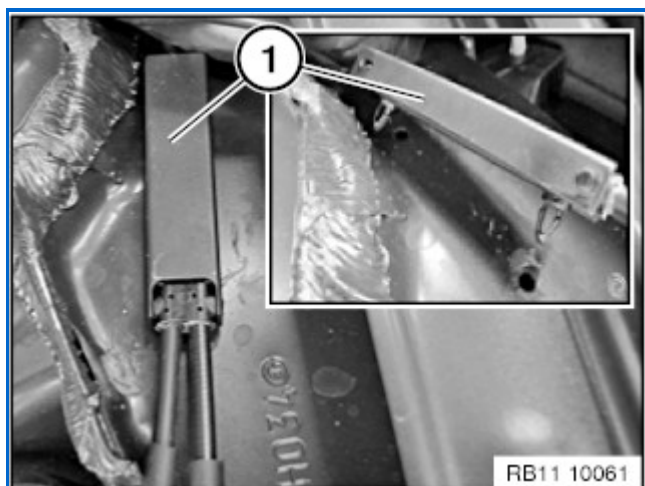
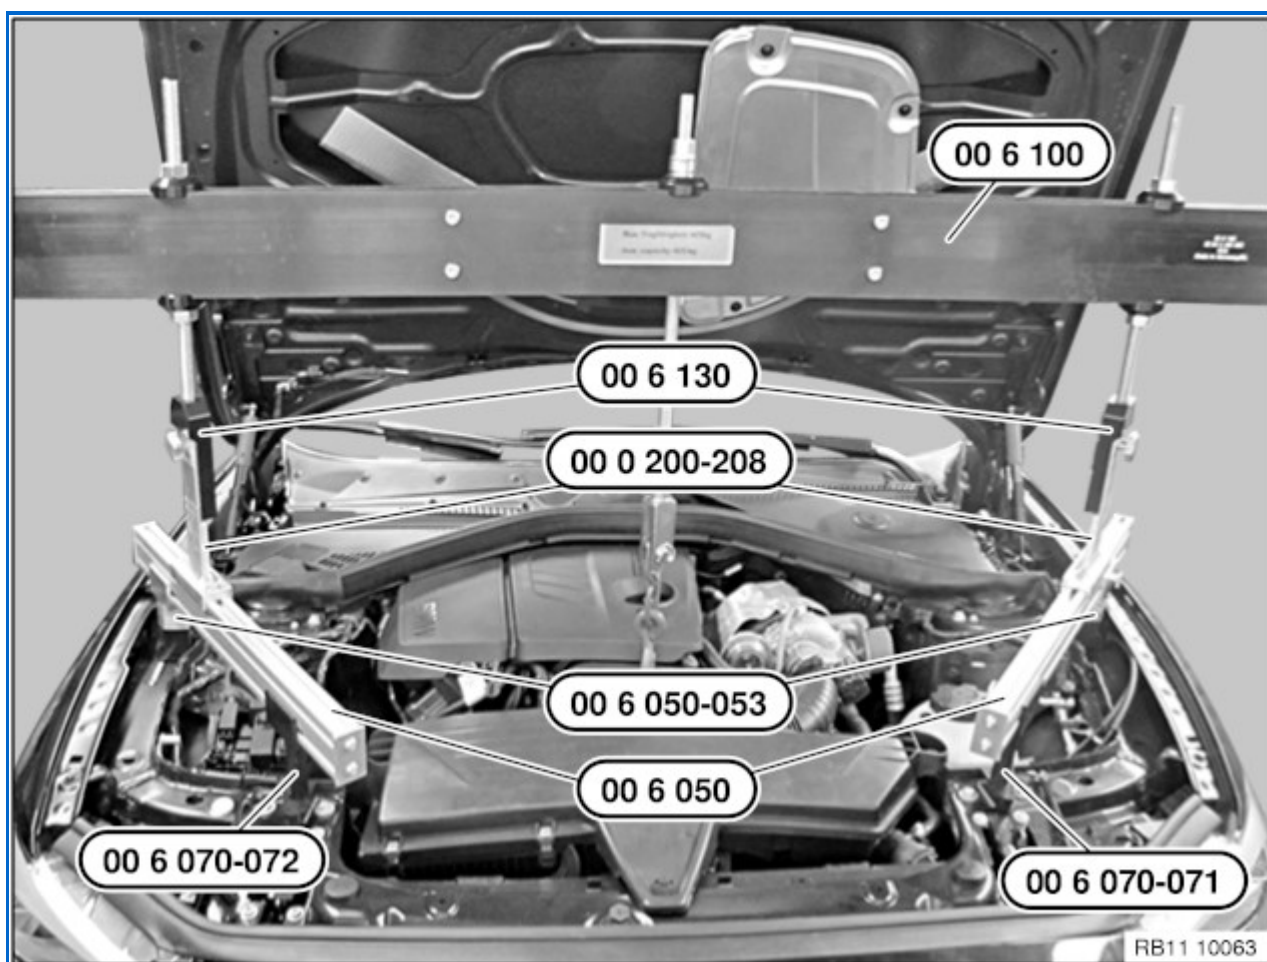
Unclip Bowden cable (1) for hood opening.

Fit cross-member [00 6 100](#) with a 2nd person helping.

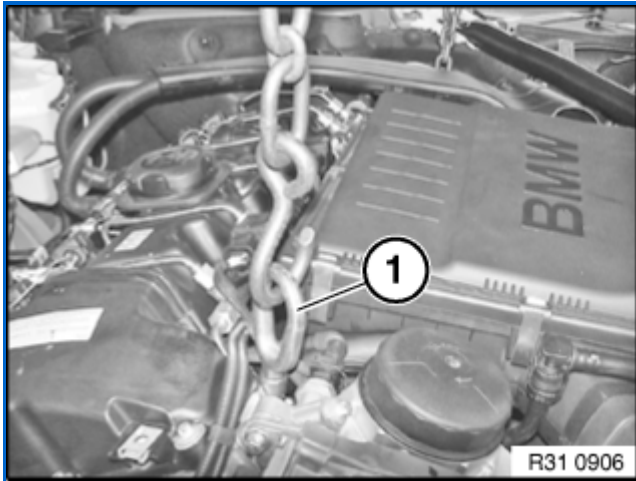
Screw towing hook (1) into engine block.

Attach chain to towing eye.

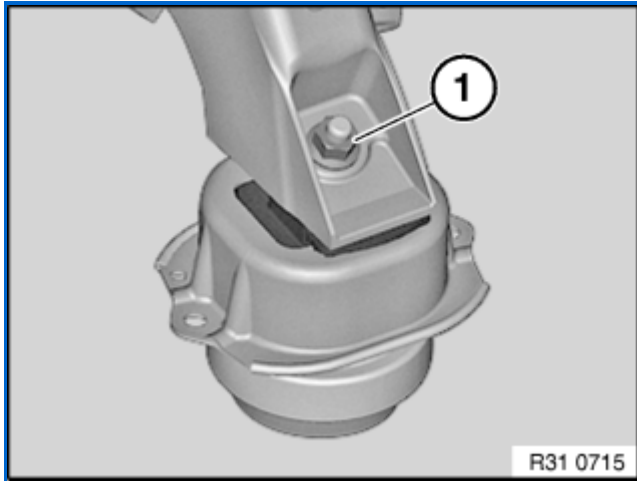
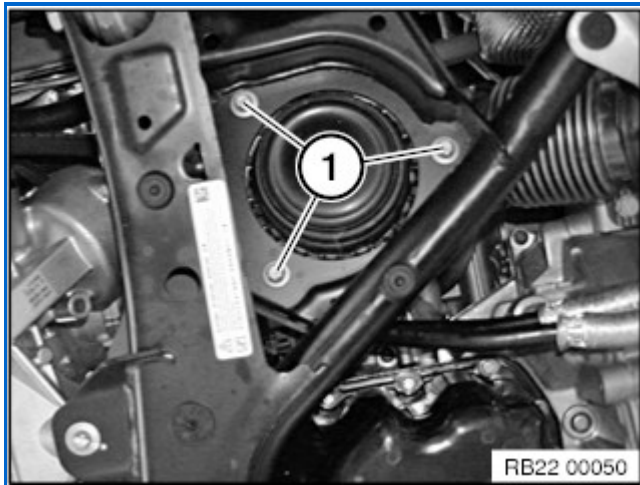
Release bolts (1) on engine mount.

Tightening torque [22 11 2AZ](#).

Release screws (1) from both engine mounts.

Raise engine approx. 10 mm with cross member.

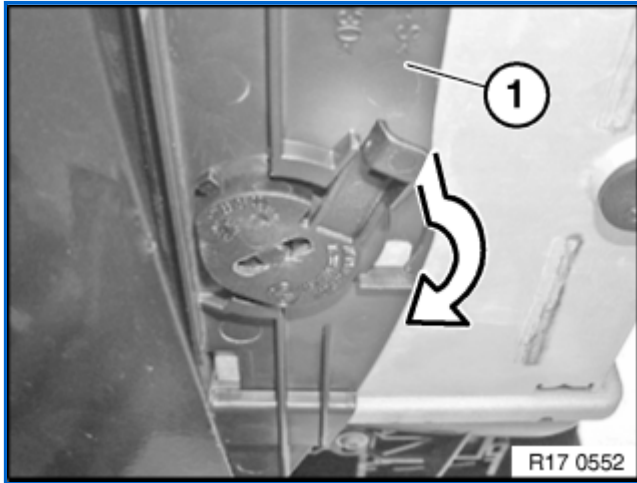
Release lock on cover (1) in direction of arrow.

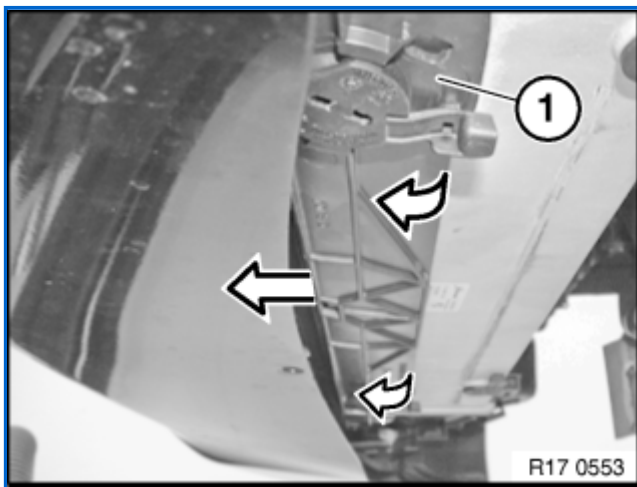
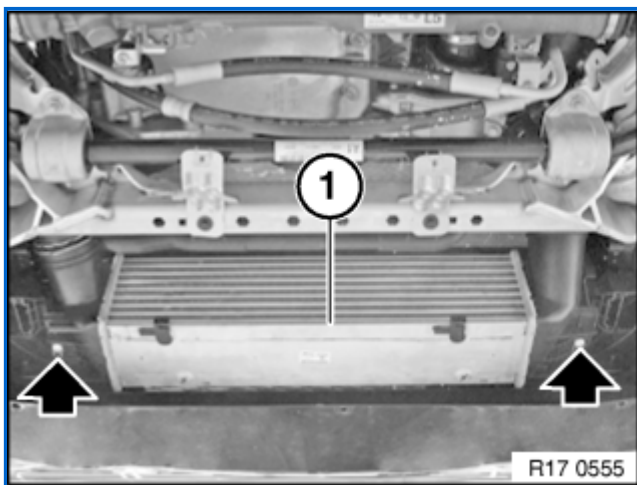
Release cover (1) in direction of arrow and remove.

Release screws and remove charge air cooler (1).

Make sure charge air cooler (1) and cooler bracket (2) are in correct installation position.

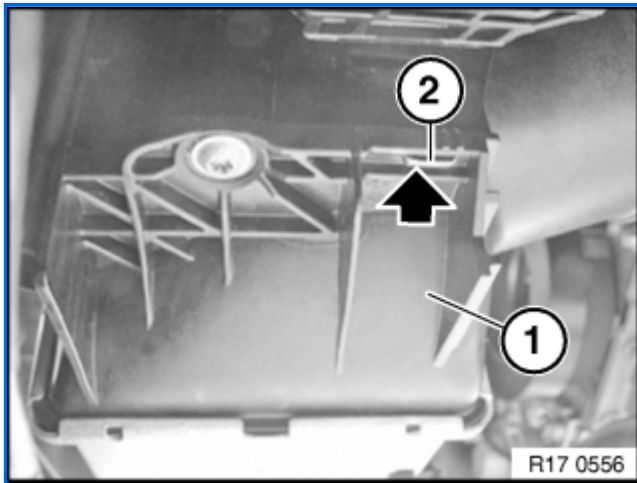
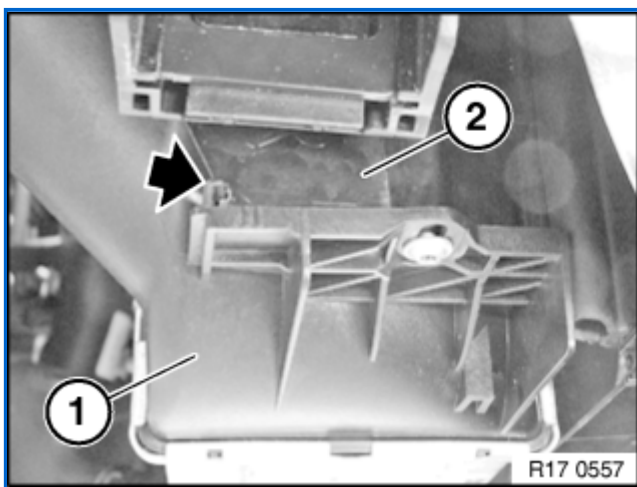
Make sure charge air cooler (1) and cooler bracket (2) are in correct installation position.

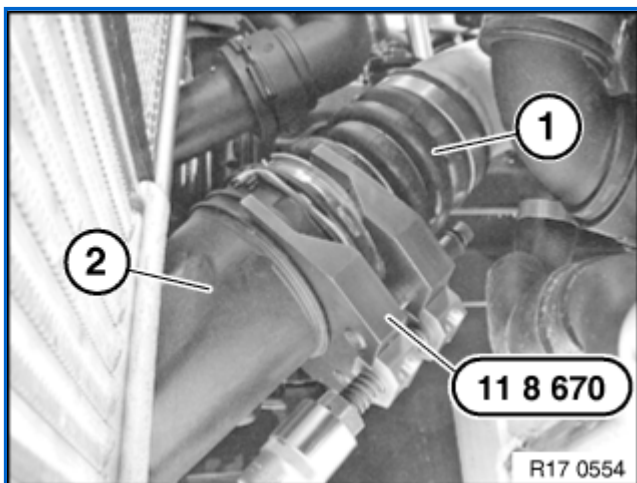
**Risk of damage** to sealing rings!

Special tool 11 8 670 is essential!

- Coat sealing rings with antiseize agent.
- Attach charge air duct (1) with special tool 11 8 670 to charge air cooler (2).
- Charge air ducts must audibly snap into place.

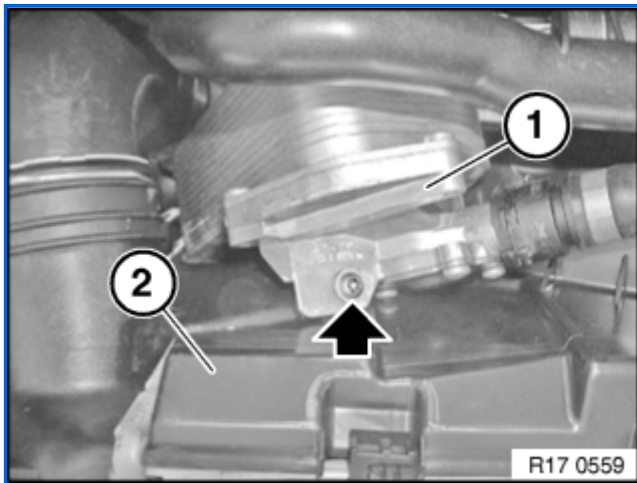
Release screw.

Detach cooler (1) for automatic transmission from fan cowl (2).

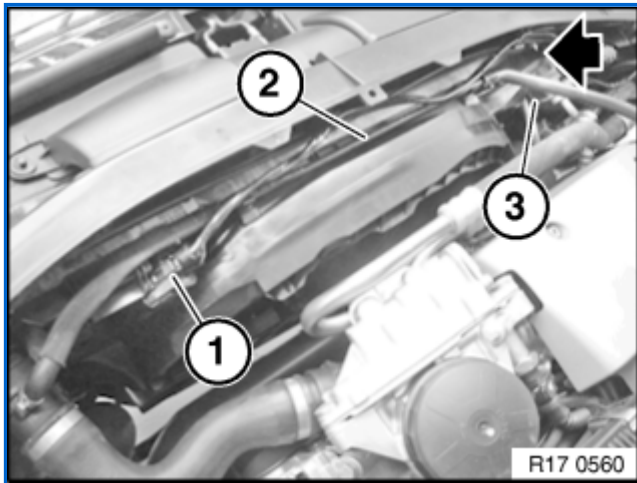
Unlock connector (1) and remove.

Unclip line (2) from fan cowl.

Cut open cable strap (3).

Release screw.

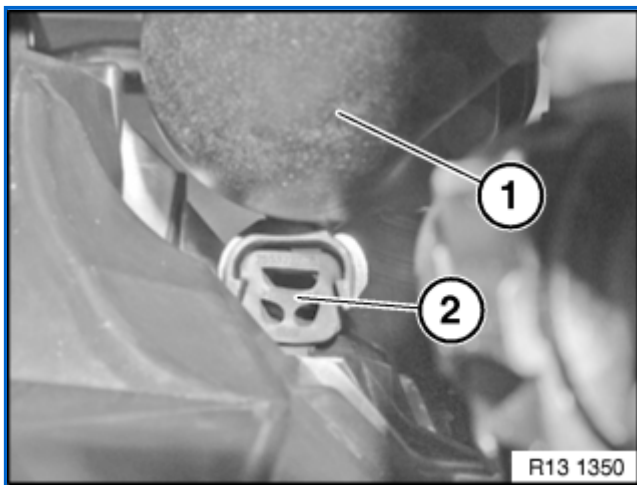
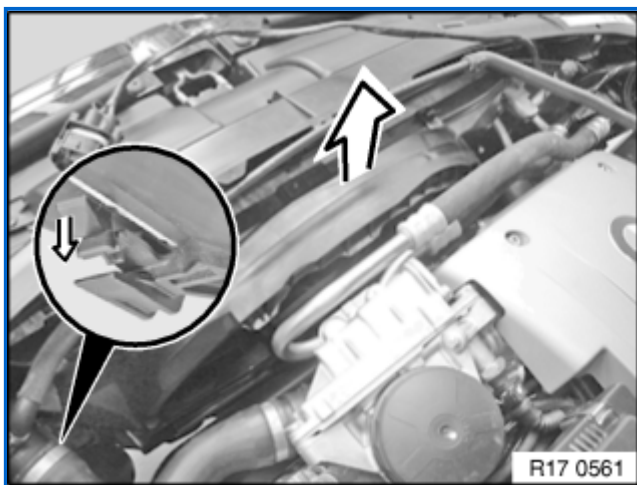
Release charge air duct (1) from rubber mount (2) on fan cowl.

Unlock catch in direction of arrow.  
Remove fan cowl towards top.

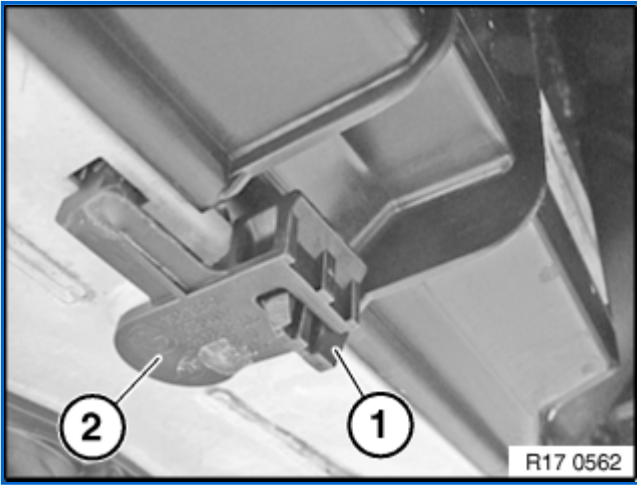
*Installation note:*  
Make sure fan cowl (1) and holder (2) are in correct installation position.

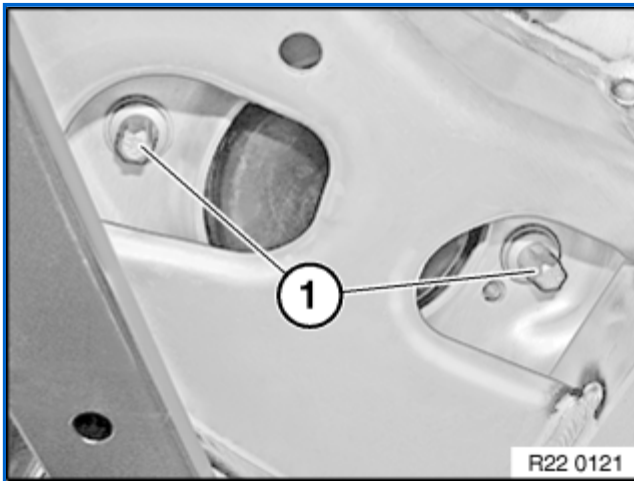
Release screws (1) and remove engine mount.

Tightening torque [22 11 1AZ](#).

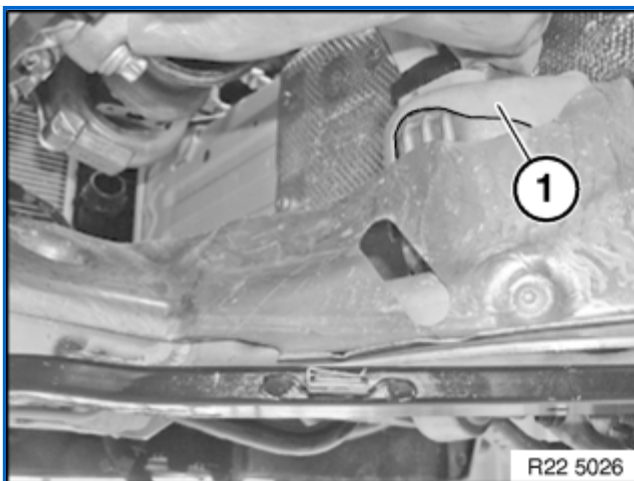
Similar to graphic.

Make sure rubber part (1) is correctly located.

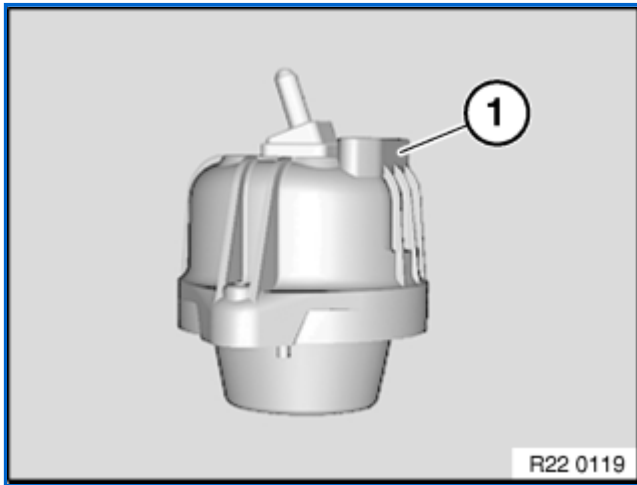
Rubber part (1) of engine mount must point to centre of vehicle.

Engine mount identification:

Right engine mount

- Even component number

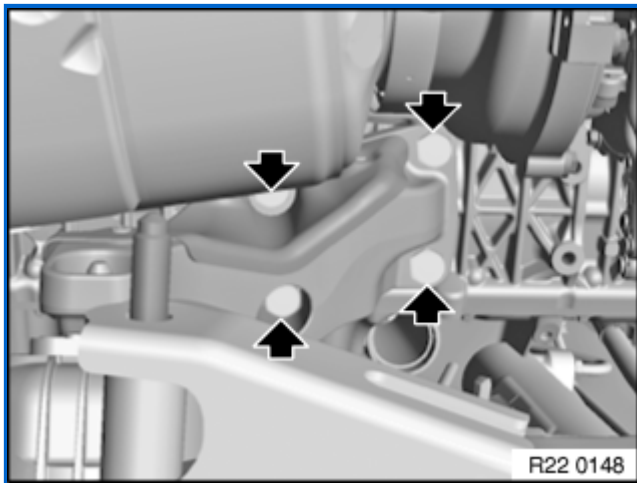
Release screws.

Remove engine support arm from engine.
